Re: Riverbank Pipe Observations
Willamette Cove Upland Facility
Portland, Oregon
ECSE No. 271
1056-03

Riverbank Pipe Observations
Port of Portland / Metro
Willamette Cove Upland Facility - Portland, Oregon

Project Name: Willamette Cove Upland Facility
Project Number: 1056-03

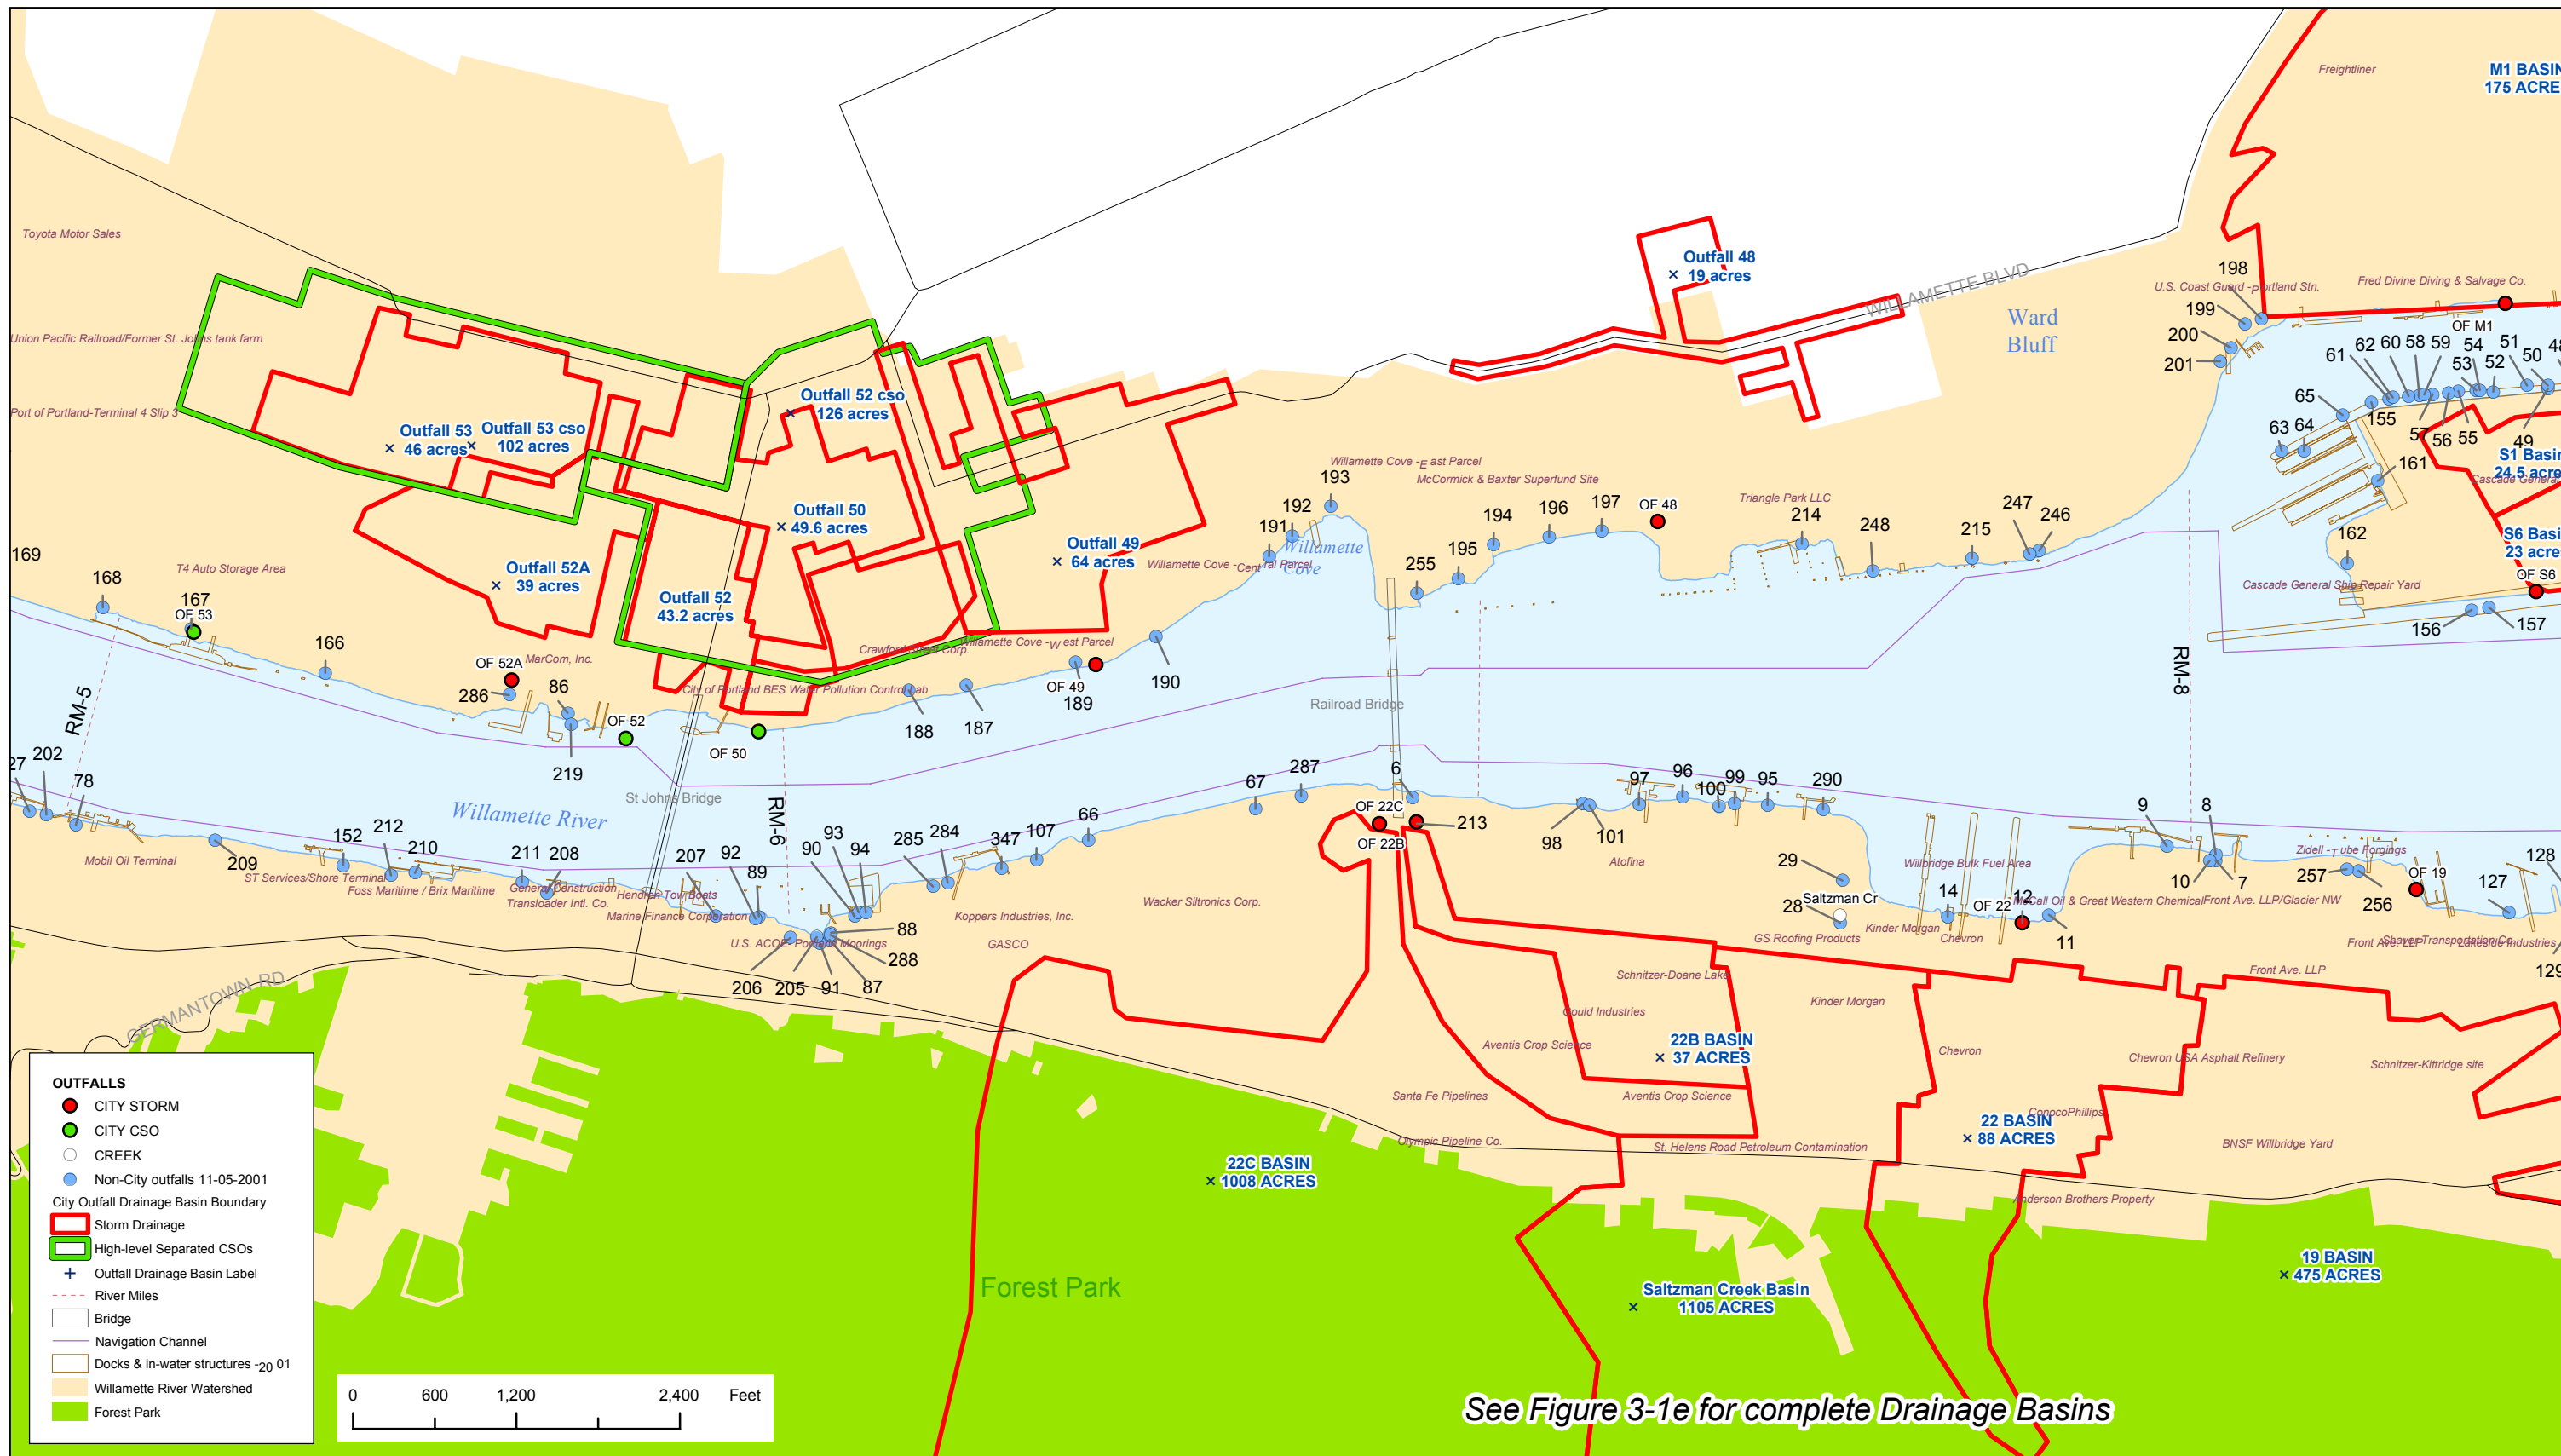
Two-foot diameter corrugated steel pipe at reported location for potential outfall WR-189. Did not appear to be an active outfall.
